# Residual moisture in the pipe?

## Pretreatment instead of tedious drying

Pretreatment of asbestos-cement wastewater pipes with residual moisture

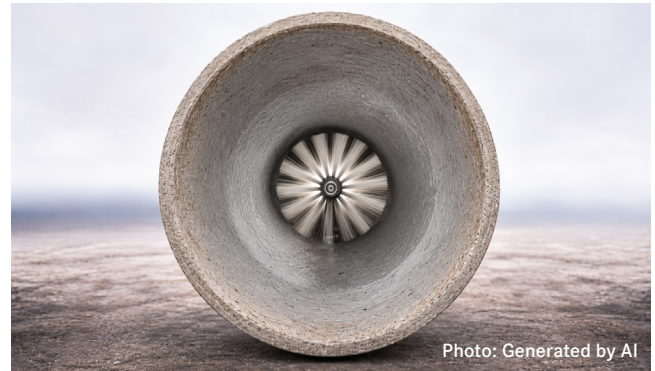
Trenchless pipe rehabilitation: After pretreatment with Collano VP 2132, the PUR coating can be applied within a short waiting time. This simplifies the process and eliminates a separate drying step.

Since September 2025, Collano and CN Technik have been testing the pretreatment under real-world conditions. After mechanical preparation, CN Technik applies the pretreatment thinly and evenly with a brush to the still moist inner surface of the pipe. Depending on the condition of the existing pipe, a second coat may be required. The two companies work closely together to coordinate substrate preparation, brush application and the subsequent PUR coating. Collano assesses the substrate and supports CN Technik in integrating the material into the existing rehabilitation process.

In the field trial conducted so far, CN Technik was able to dispense with additional hot-air drying after applying the pretreatment. Depending on the ambient temperature and amount applied, the surface was ready for PUR coating after approximately 10 to 20 minutes. This eliminates the need for a separate drying step. It simplifies the workflow and reduces the use of hot-air equipment. Residual moisture can be bridged, particularly at pipe joints, transitions and hard-to-reach areas.
